PHASE I INSPECTION REPORT  
NATIONAL DAM SAFETY PROGRAM

LONE TREE CREEK BASIN  
VAUX #1 AND VAUX #2 DAMS  
SIDNEY, MONTANA  
MT-357 AND MT-358

MORRISON - MAIERLE, INC.

FEBRUARY, 1980

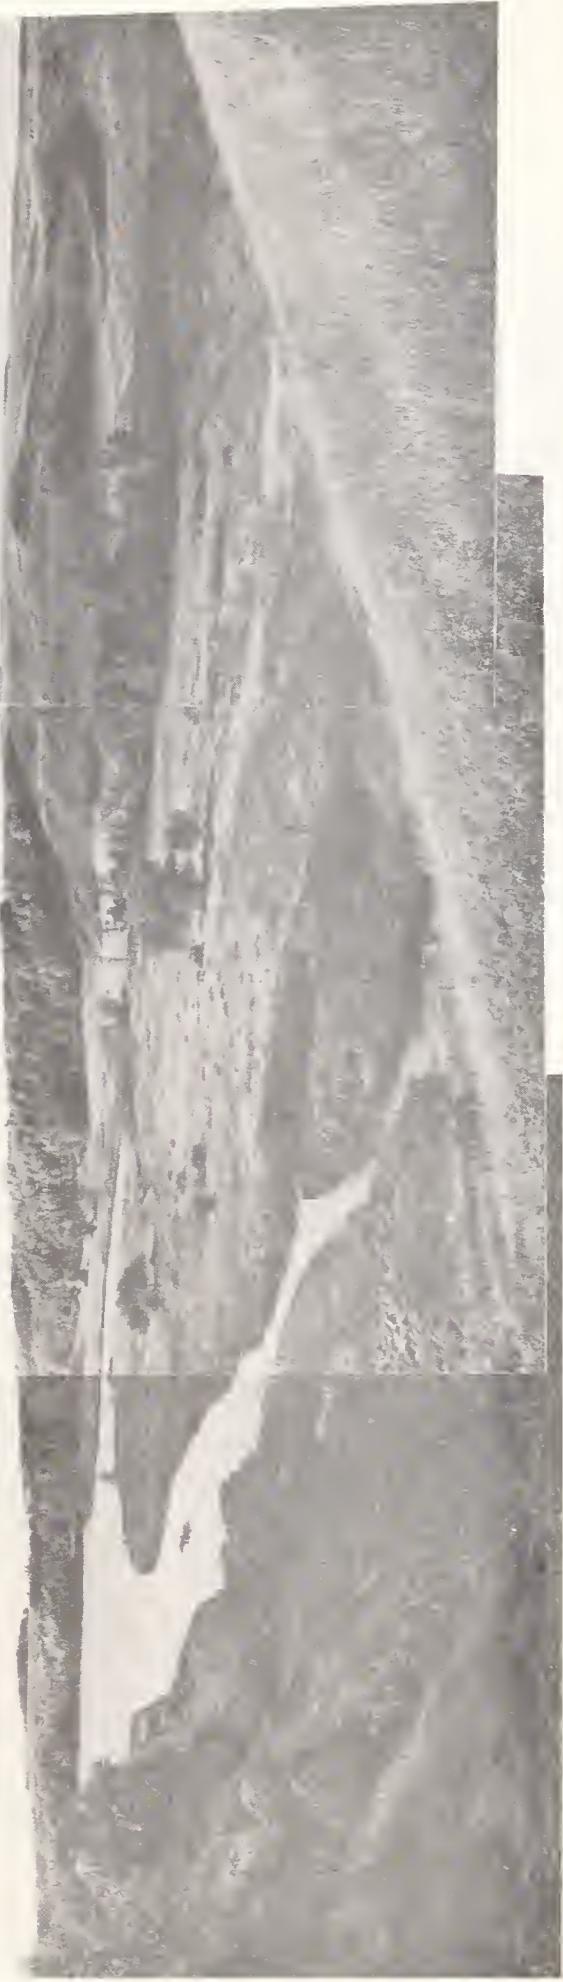
**PHOTO 5 VAUX #2 OUTLET CHANNEL LOOKING DOWNSTREAM TOWARD VAUX #1 RESERVOIR**

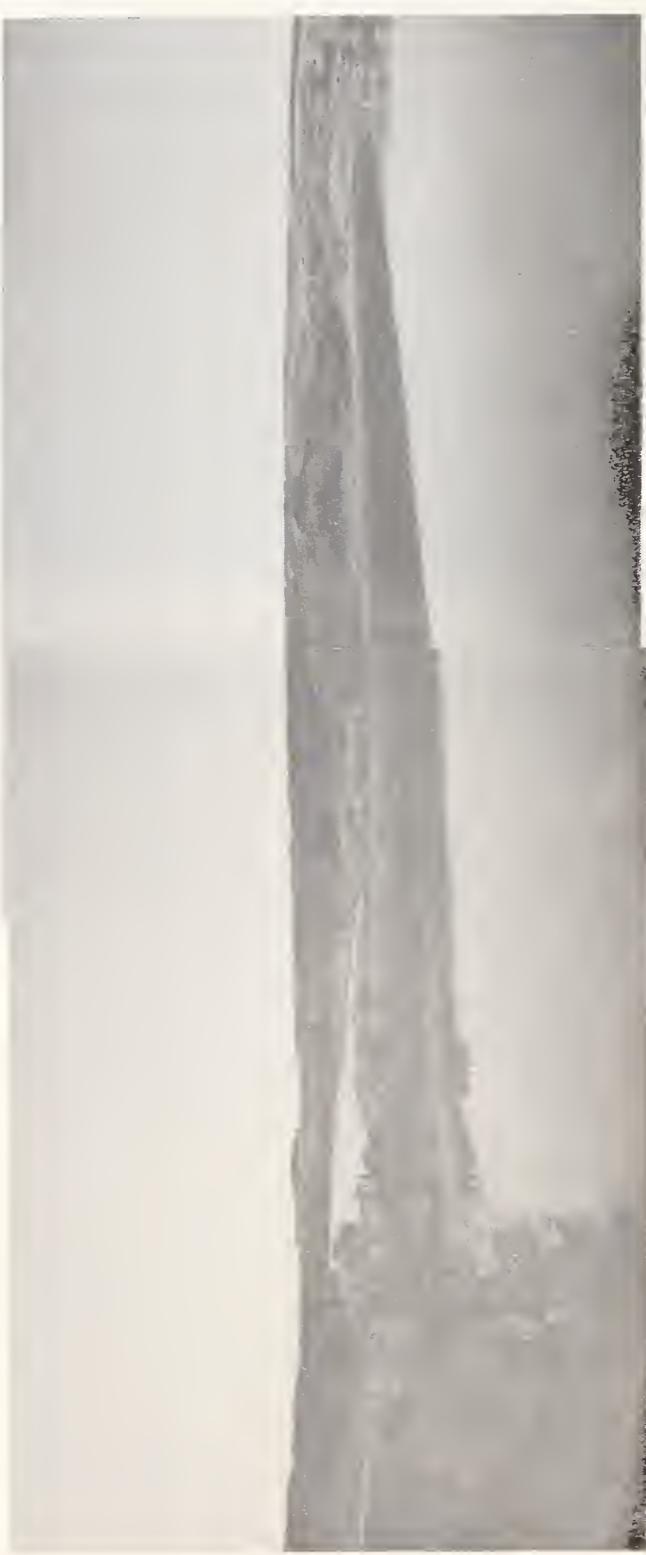
**PHOTO 4 VAUX #2, UPSTREAM FACE AND VAUX #1 RESERVOIR**

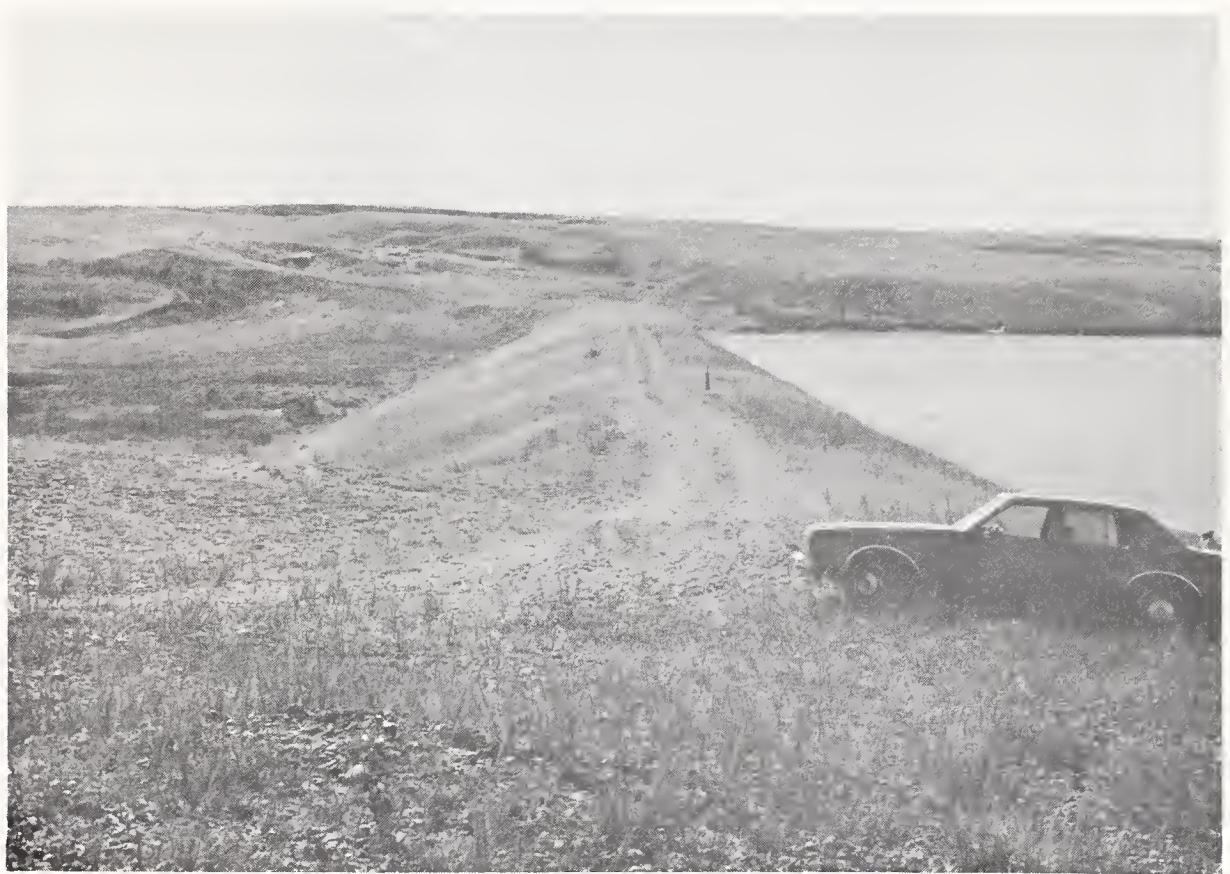
**PHOTO 6 VAUX #2 FROM NORTH ABUTMENT**

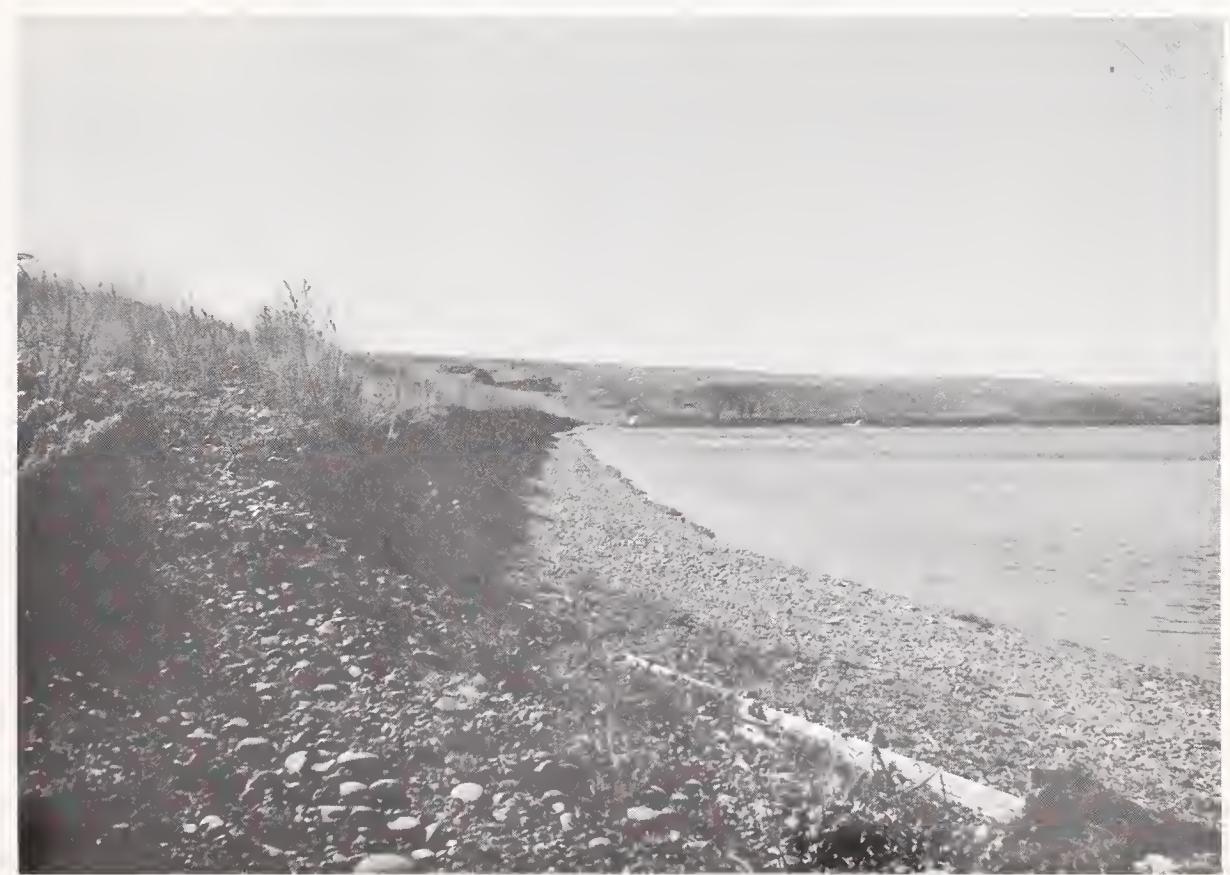
The gravel shell surfaces of the dam are bearing up well under 18 years of performance on both faces of the dam and show no sign of instability or damage except for a wave cut bench on the upstream face. Wave action during the past 18 years has cut a bench in the upstream embankment face of Vaux #1 that has a 4 to 5 foot high vertical scarp (Photo 7). With the absence of riprap protection on the upstream dam face, wave erosion could be expected to continue. Also surface drainage from the road at the right abutment is directed down the upstream face of the dam at the point of contact between the dam and natural ground (photos 26 and 27). This area is heavily grassed and no erosional damage to the embankment has resulted.

**PHOTO 7 VAUX #2 UPSTREAM FACE WAVE EROSION**

- Repair eroded areas of upstream face of embankments and place adequate riprap protection.

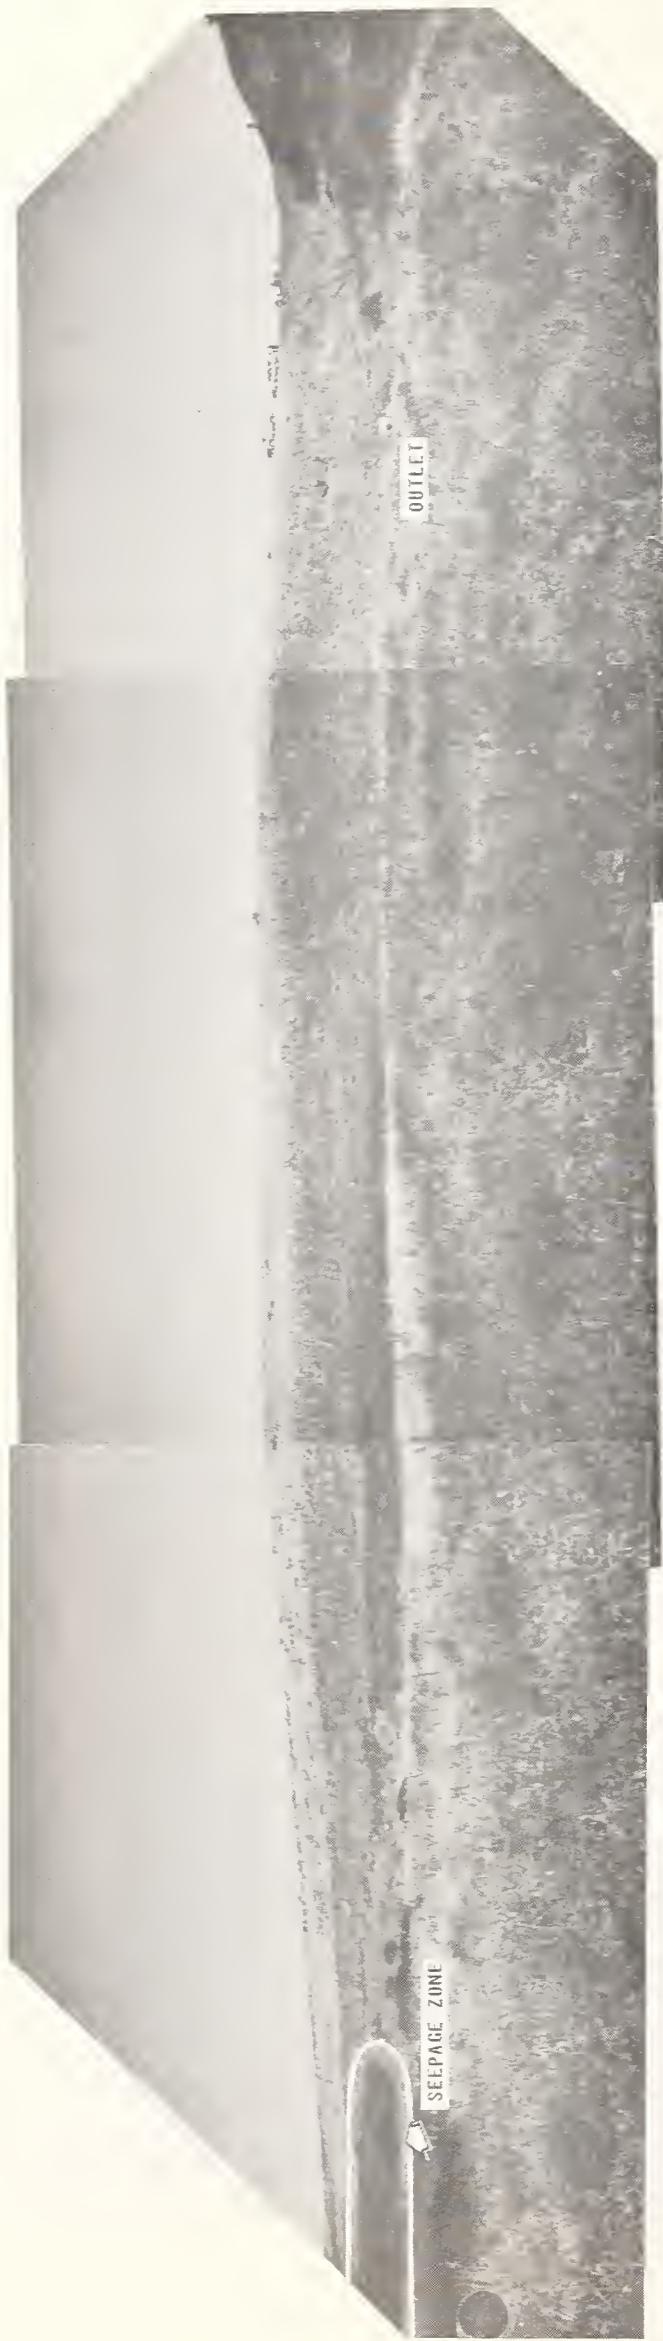
PHOTO 8 VAUX #2 DOWNSTREAM FACE

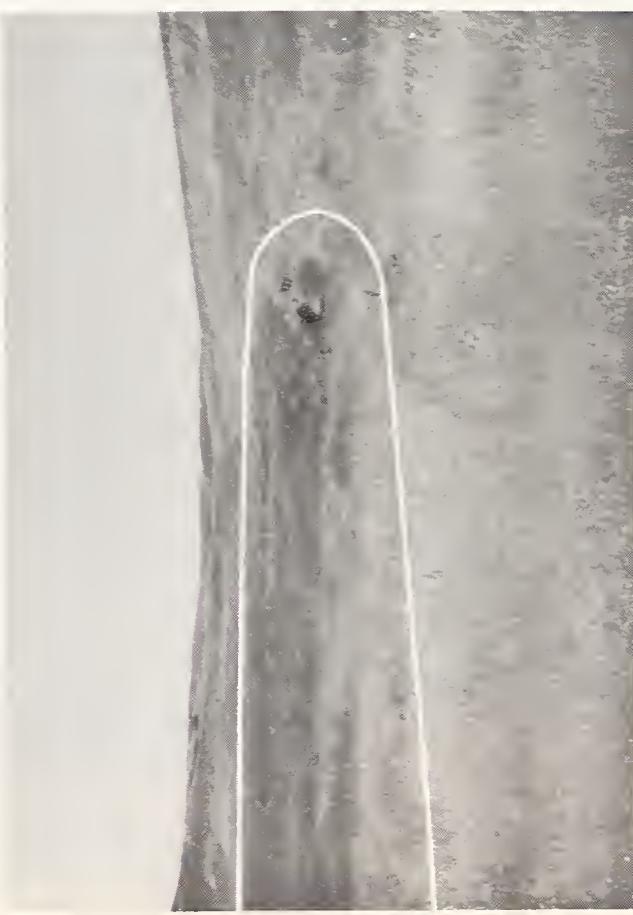
PHOTO 9 VAUX #2 SOUTH ABUTMENT DOWNSTREAM FACE

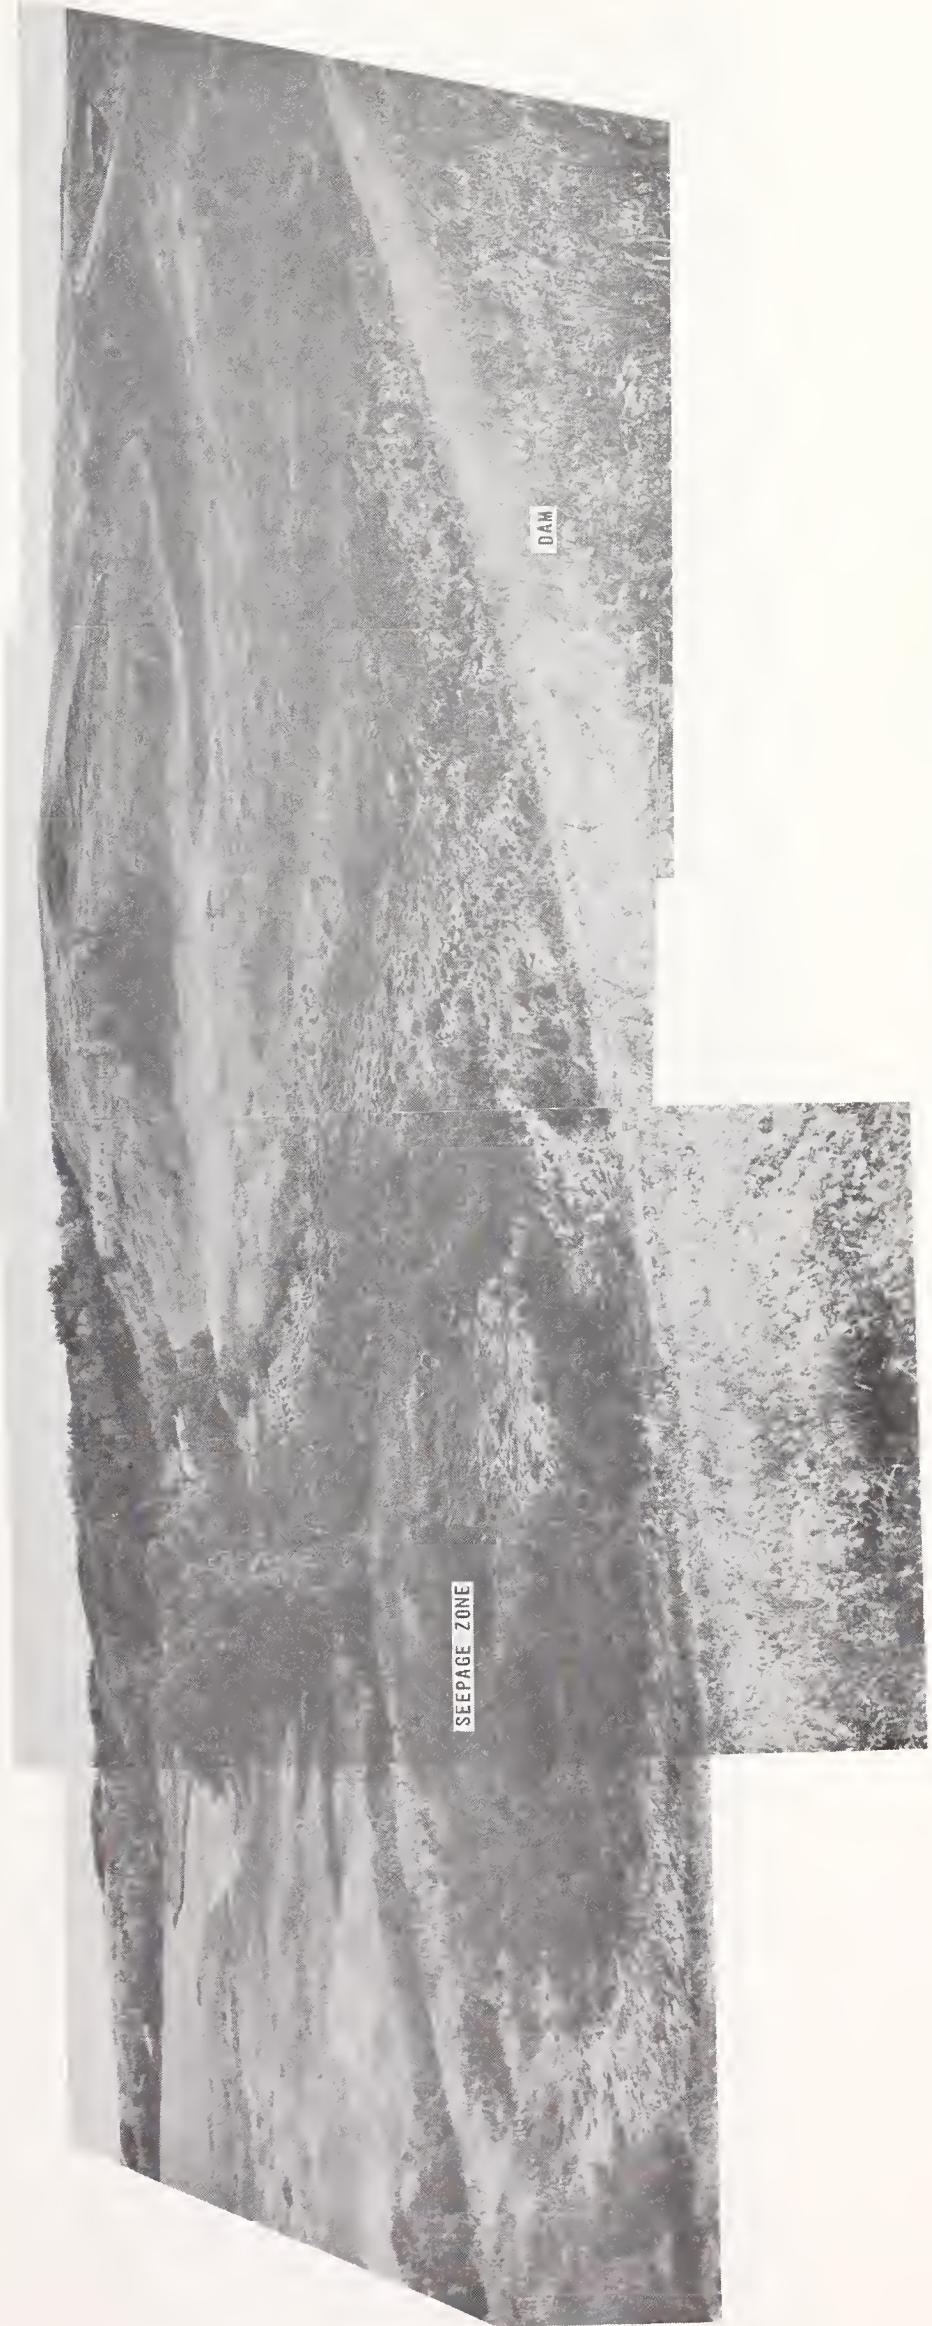
**PHOTO 10 VAUX #2 SEEPAGE AREA AT TOE OF SOUTH ABUTMENT TAKEN FROM DAM**

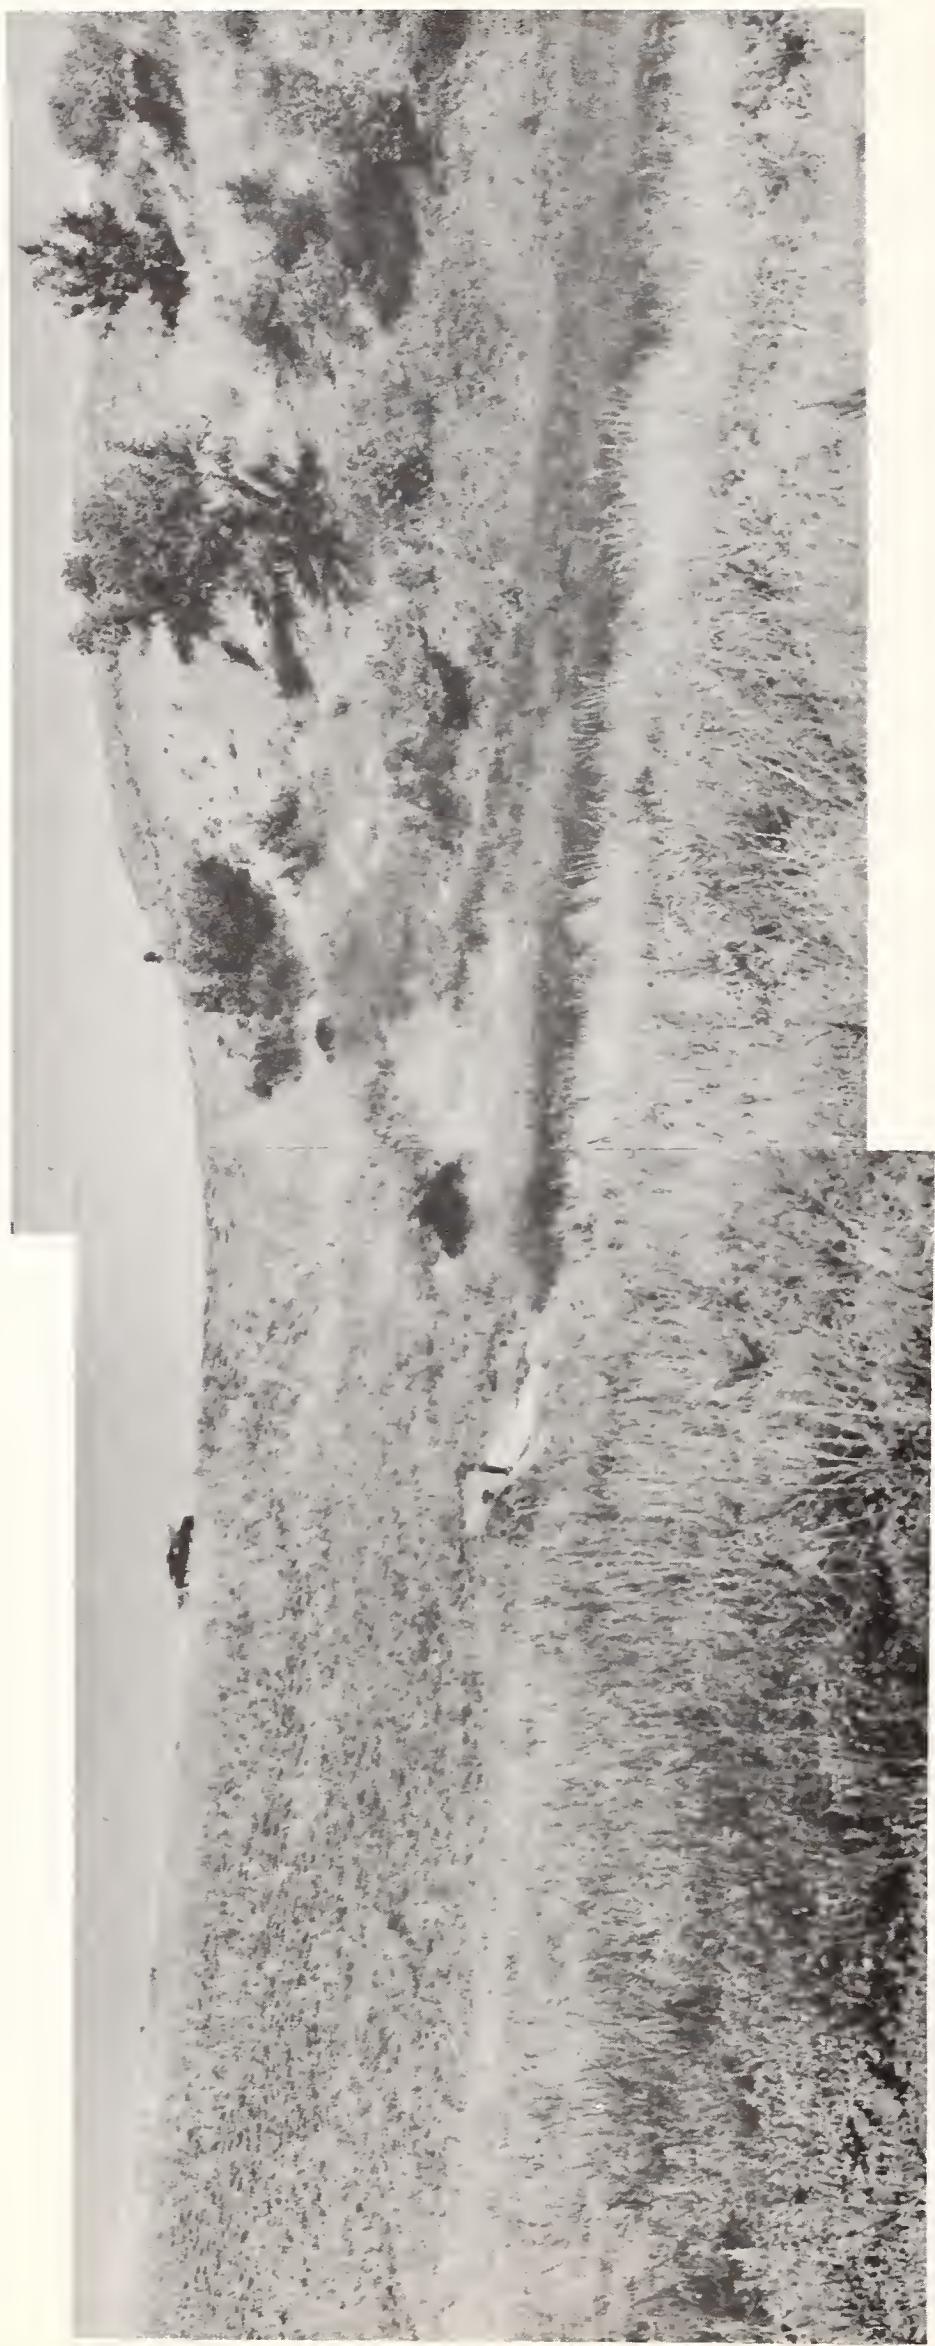
PHOTO 11 VAUX #2 NORTH ABUTMENT AND OUTLET

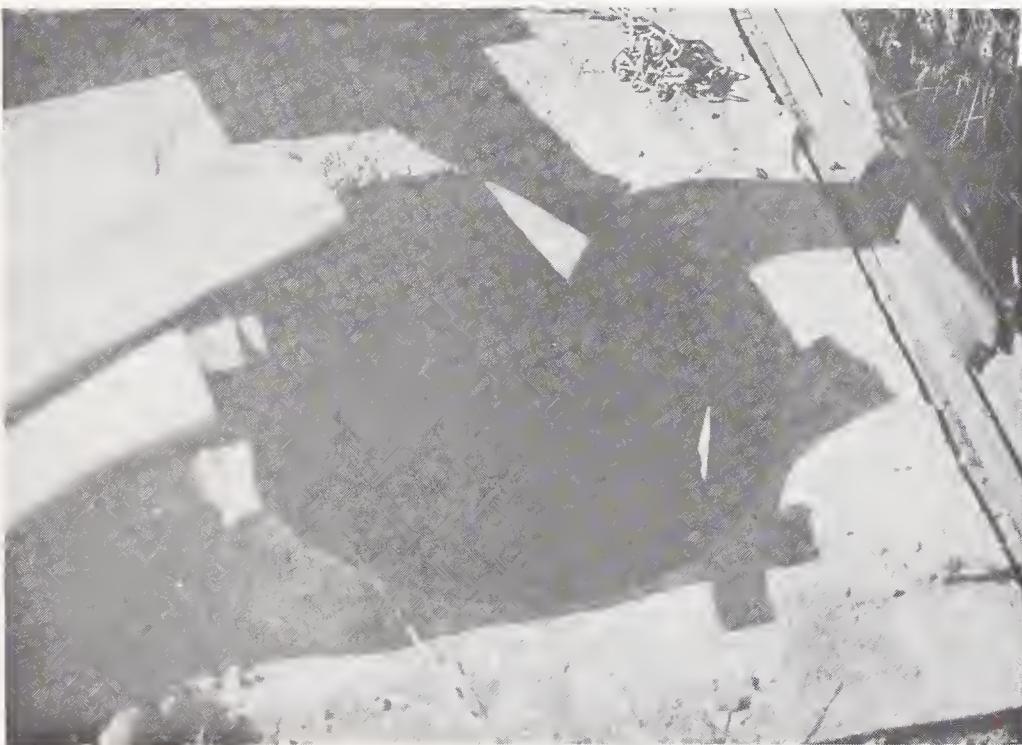
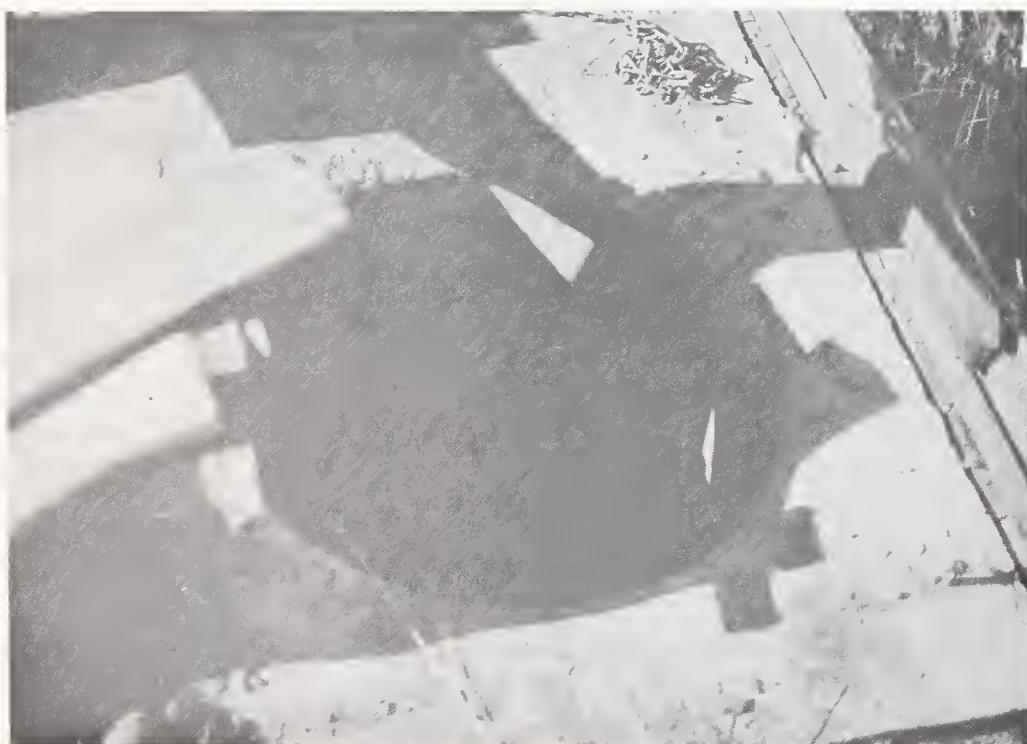
**PHOTO 13  
VAUX #2 GATE SHAFT  
WET WELL**

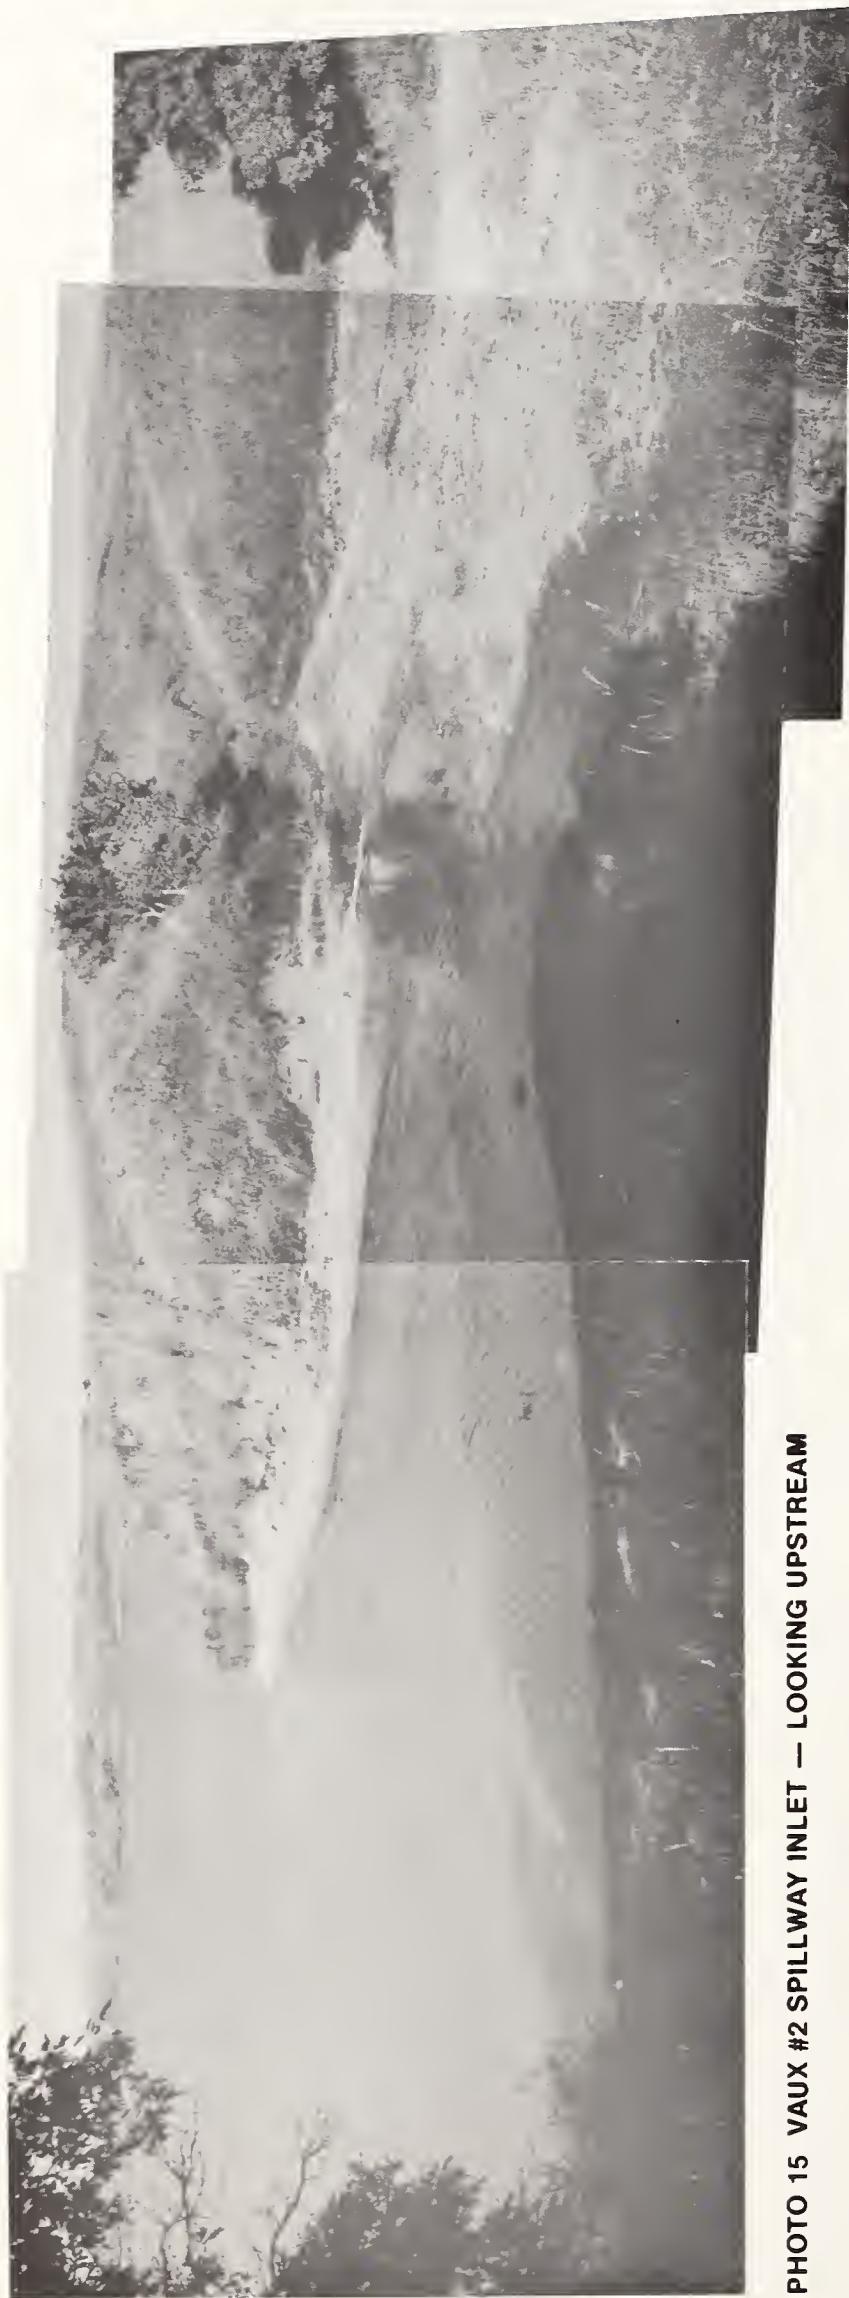
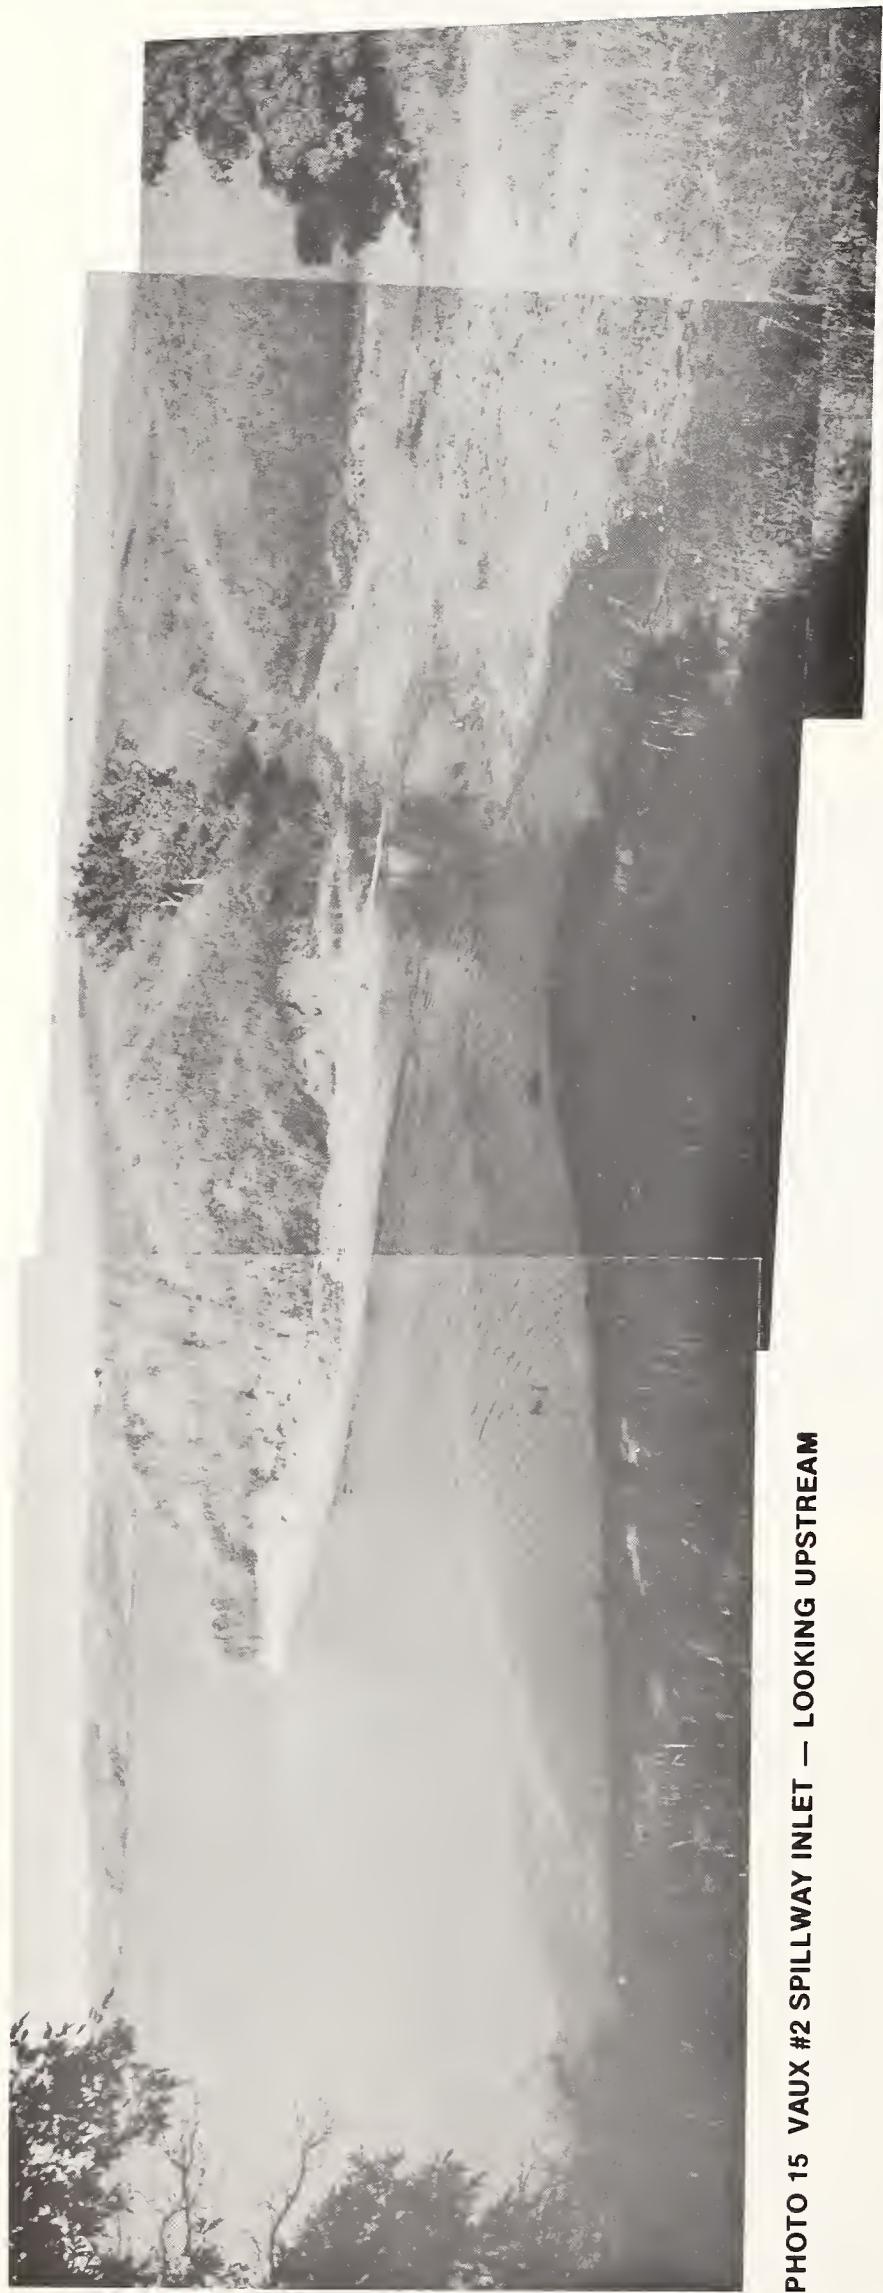
PHOTO 15 VAUX #2 SPILLWAY INLET — LOOKING UPSTREAM

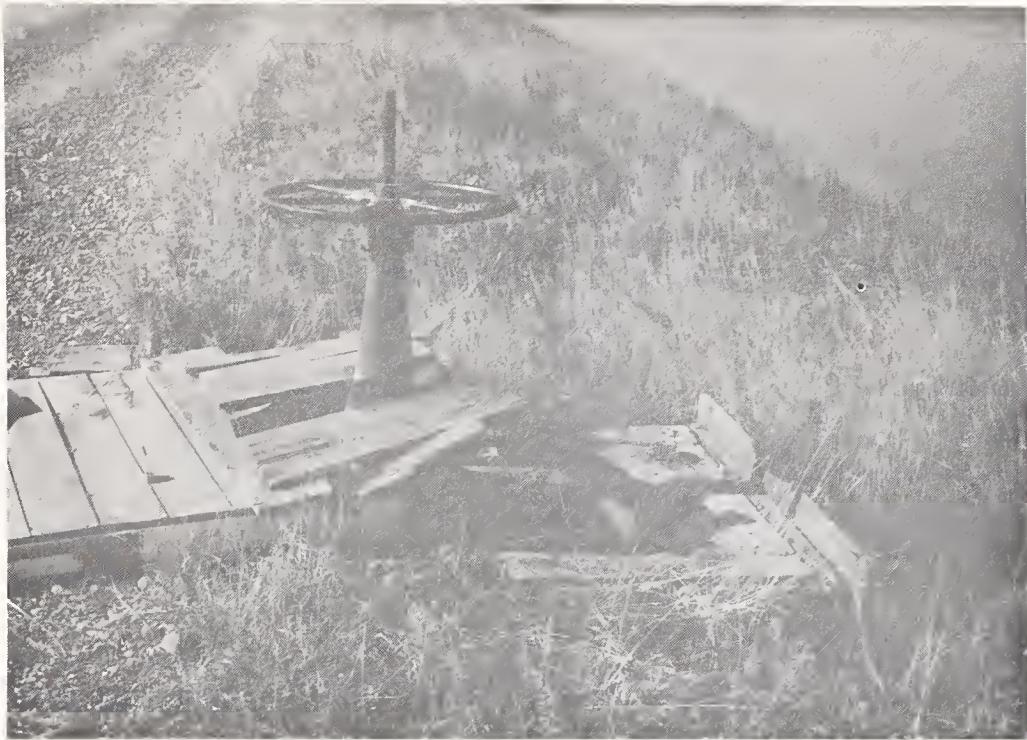
The slide gate is located in a 48-inch diameter manhole gate shaft which rises to the crest of the dam. The gate control consists of a gate stem connected to a wheel mounted on the concrete cover to the gate shaft (Photo 12). According to the owners, the slide gate binds during closure but has not prevented operation of the gate. The gate was operated during the inspection and appeared in good operating condition. At maximum pool the outlet capacity is approximately 65 cfs.

**PHOTO 12  
VAUX #2 GATE CONTROL**

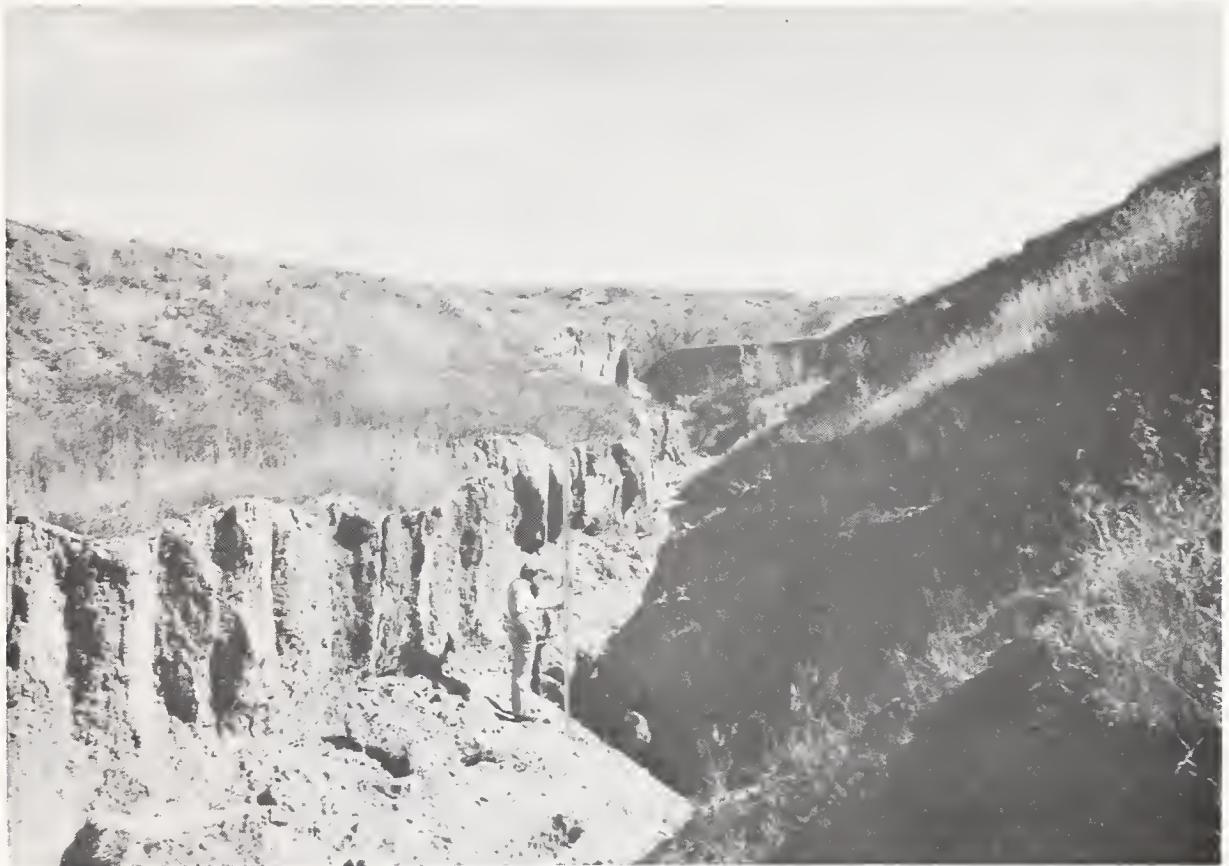
PHOTO 17 ERODED SECTION OF SPILLWAY APPROXIMATELY 1300 ft. DOWNSTREAM OF INLET

- Prior to next refill period, accomplish remedial repair to the Vaux #2 Dam spillway channel to arrest the erosion that has occurred about 1300 feet downstream from the entrance.

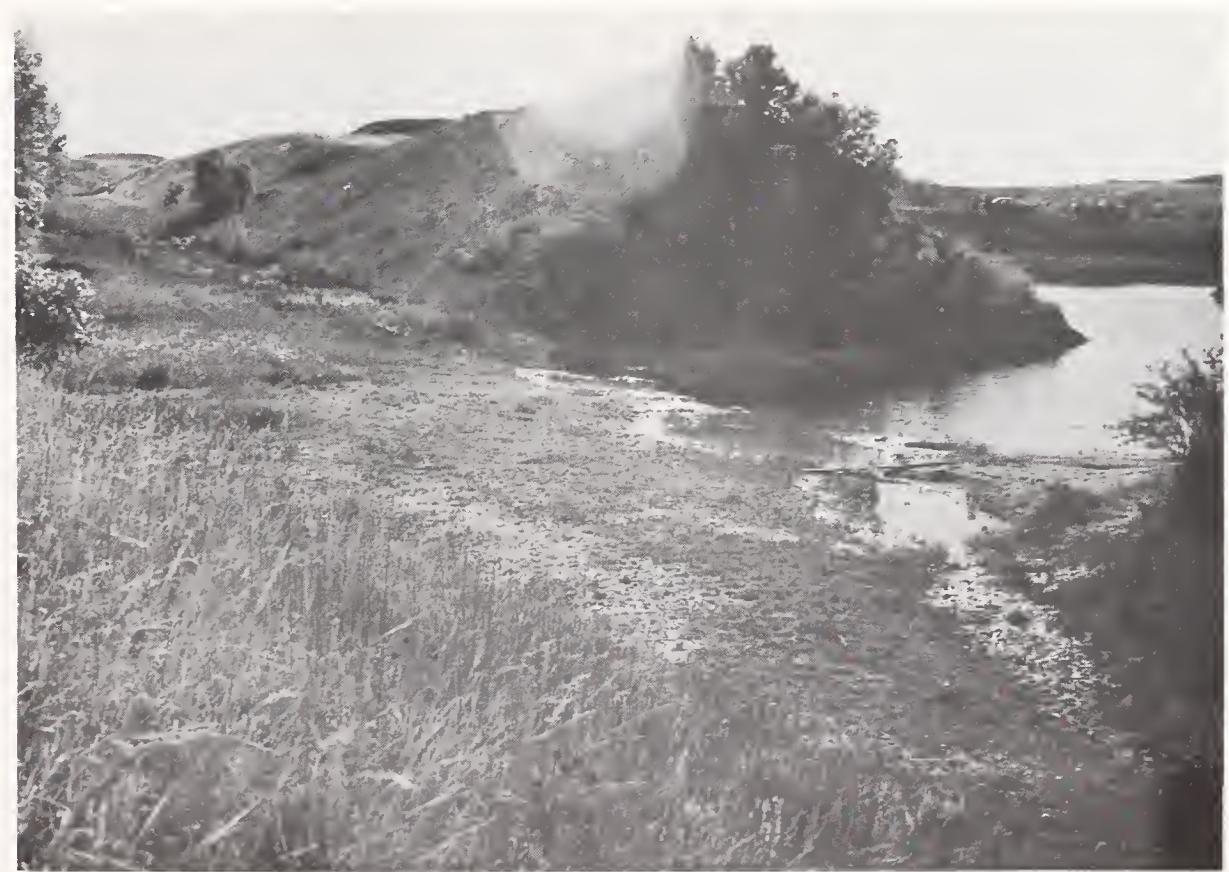
PHOTO 16 VAUX #2 SPILLWAY INLET AND CHANNEL LOOKING DOWNSTREAM

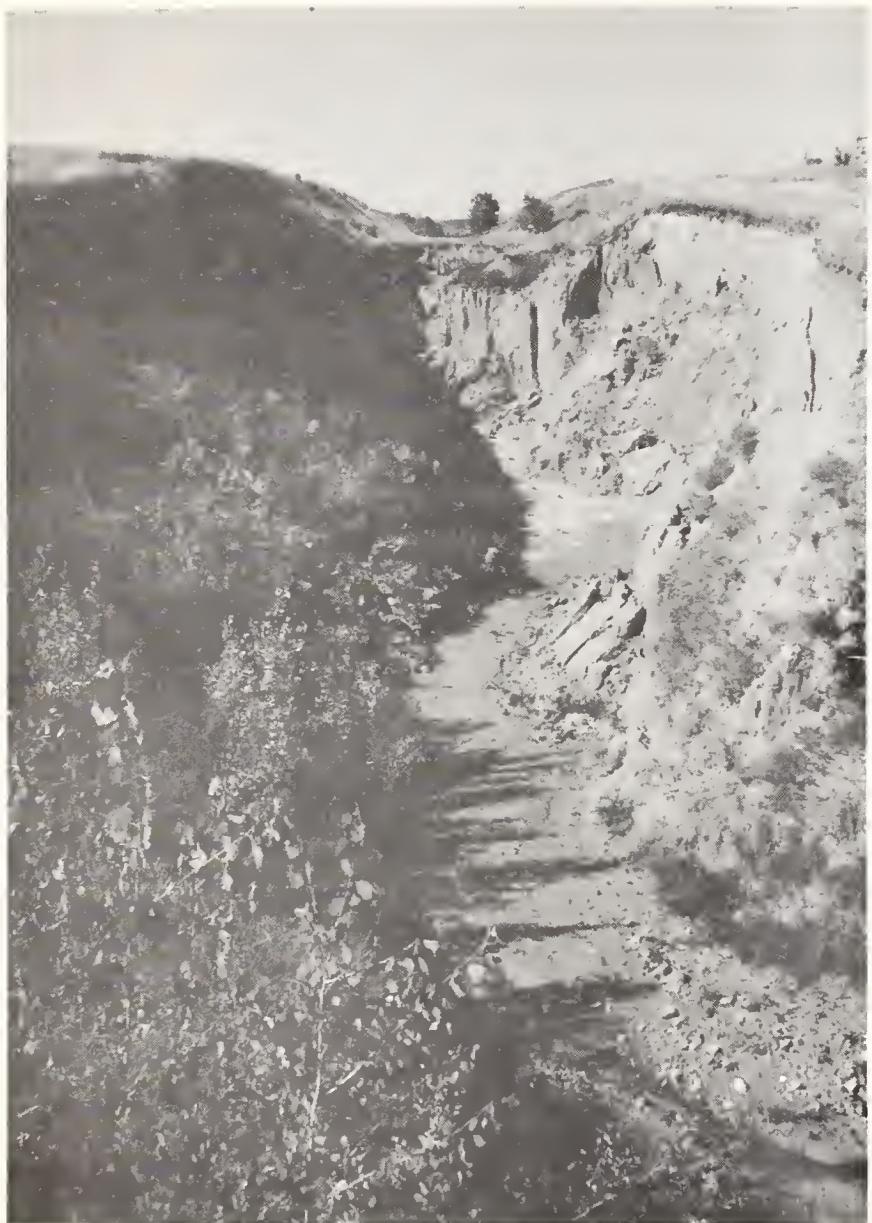
PHOTO 18 ERODED SECTION OF SPILLWAY — LOOKING UPSTREAM

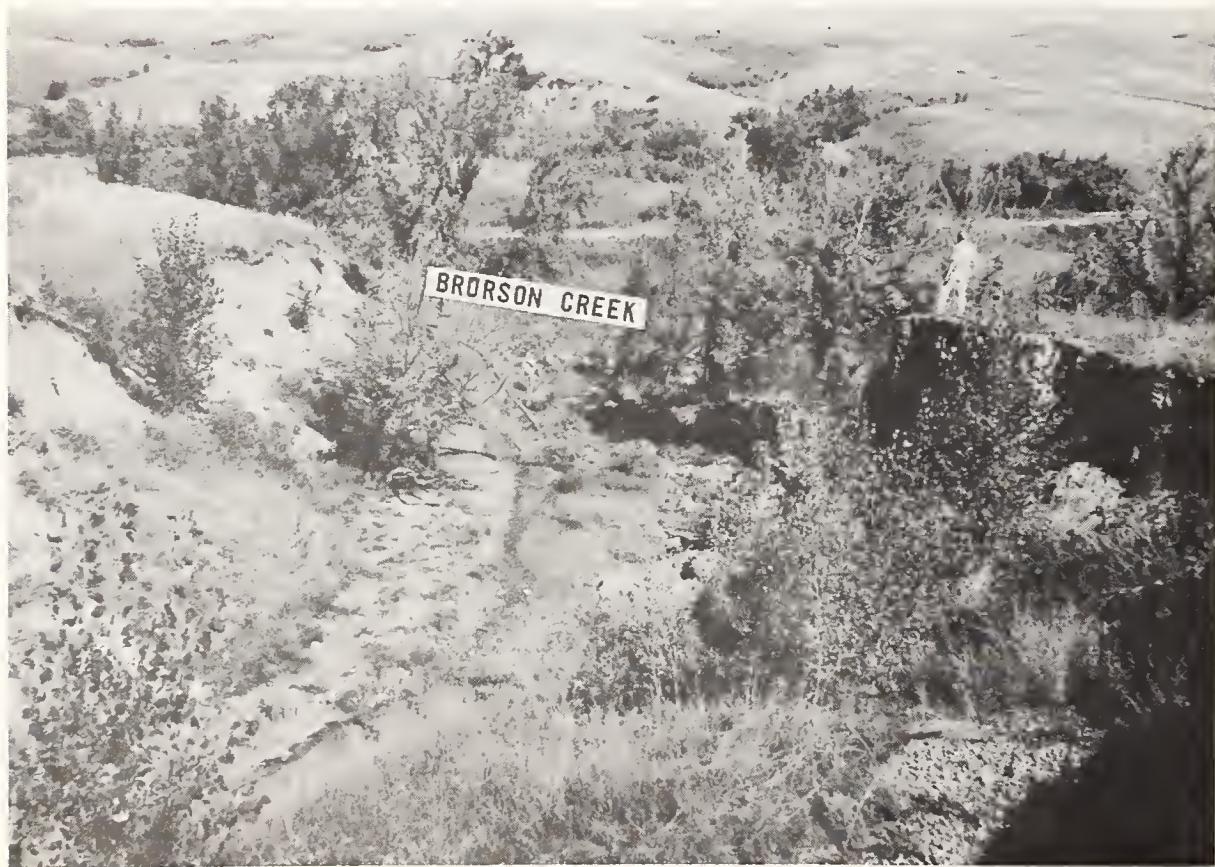
PHOTO 19 OUTLET OF SPILLWAY CHANNEL AT BRORSON CREEK

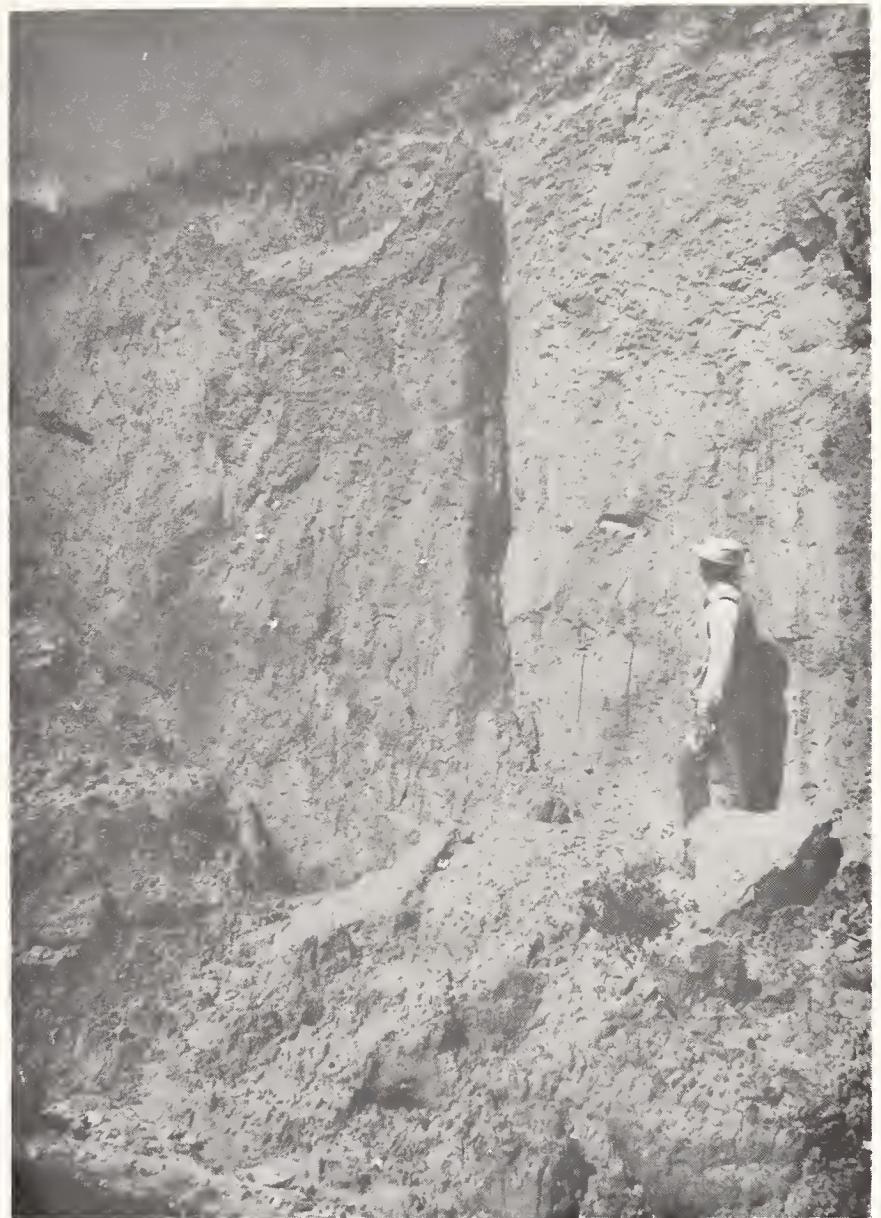
PHOTO 20 GLACIAL TILL IN SPILLWAY
